# Manhole Inspection Summary

Manhole # S31M\_\_004MH

Insp Date: **12/31/08 12:42 PM**

**Location** Address: **Russel St.**

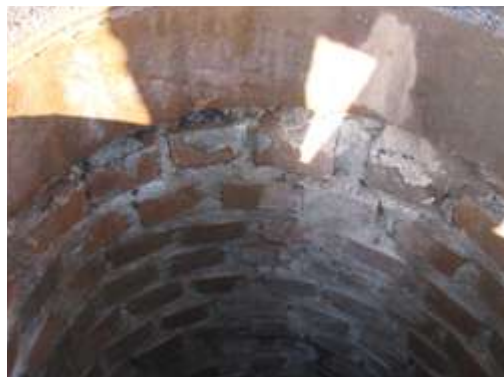
Defect 2

Condition: ☐ Sound ☐ Cracked ☐ Root Intrusion ☒ **Loose Brick** ☐ Deteriorated

chimney loose bricks at frame joint

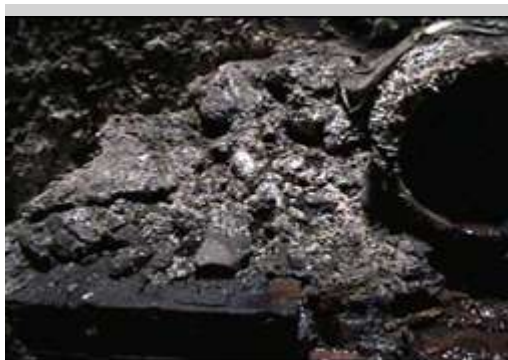
Defect 3

Condition: ☐ Sound ☐ Cracked ☐ Root Intrusion ☐ Deteriorated ☐ Leaks ☒ **Debris**

bench debris

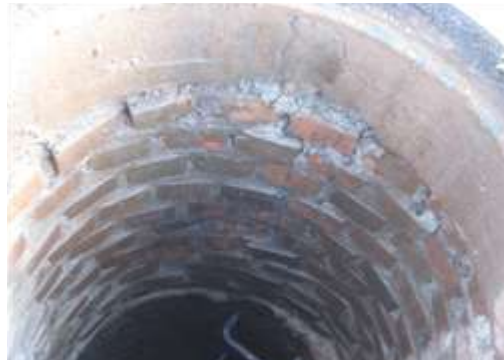
Defect 1

Infiltration: ☐ None ☒ **Joint** ☐ Cracks ☒ **Mortar** ☐ Roots ☐ Wall

Infiltration: ☐ None ☐ Joint ☐ Cracks ☐ Mortar ☐ Roots ☒ **Wall**

chimney infiltration at frame joint & mortar as well as from corbel wall

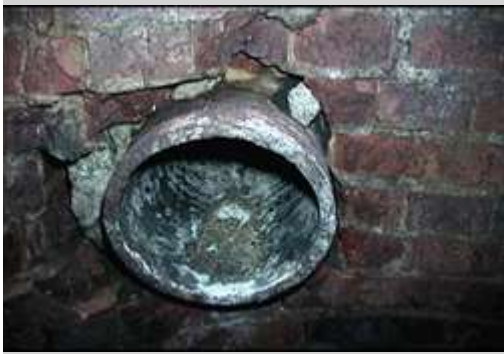
### Defect 4

Condition: ☐ Sound ☒ **Cracked** ☐ Root Intrusion ☐ Loose Brick ☒ **Deteriorated**

cracked & deteriorated brick in barrel wall

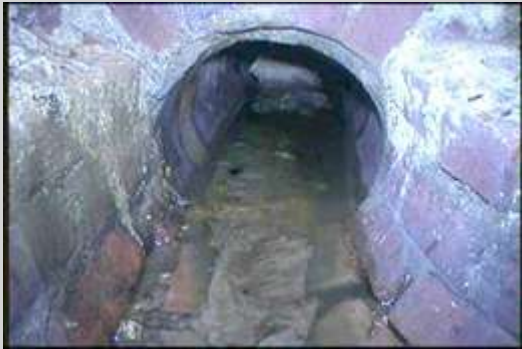
12 O'Clock Outflow

Pipe Height: **10.8** (in.) Rod and Bar (Angled)  
Pipe Material: **Clay** ☐ Pipe Lined  
Invert Depth: **15.29** (ft.) Flow Characteristics: **None**  
Deposits: ☐ None ☐ Mud ☐ Sludge ☒ **Debris** ☐ Grease  
Silt Depth: **0** (in.) Deposits Extent: **Heavy**  
Infiltration: **None** Pipe Seal Cond: **Sound**
